NASA TN D-2391

YLR99-RM-1 ROCKET ENGINE OPERATING EXPERIENCE IN THE X-15 AIRCRAFT

*Flight Research Center
Edwards, Calif.*

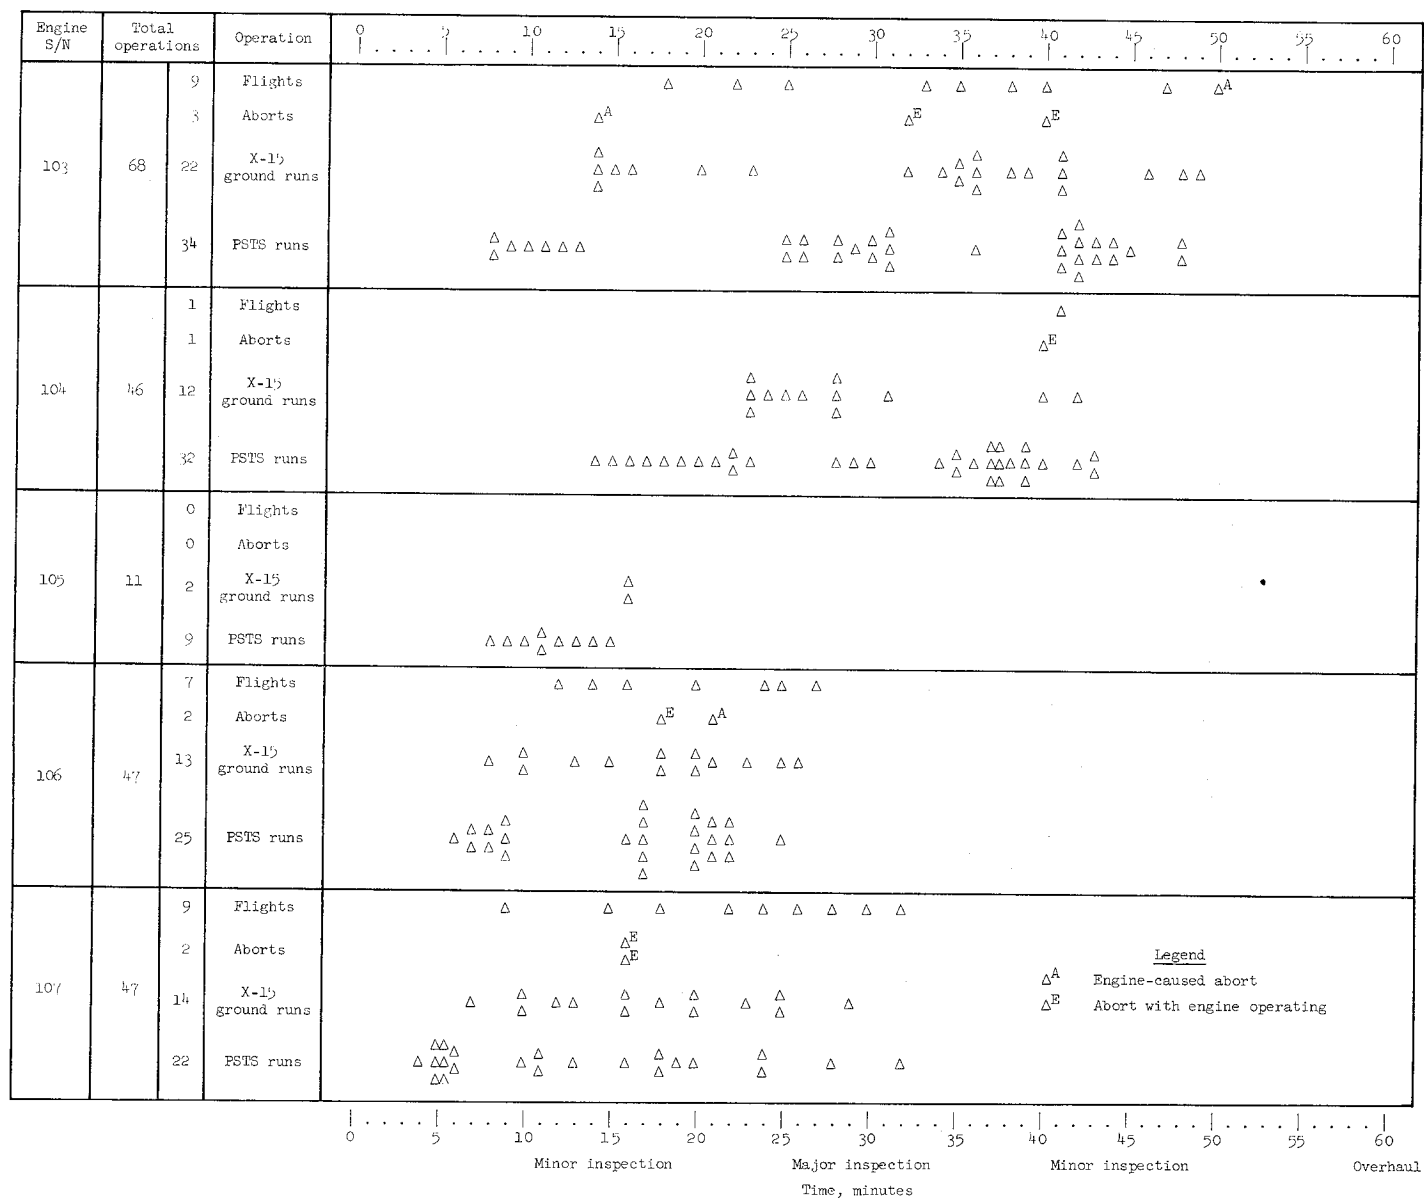
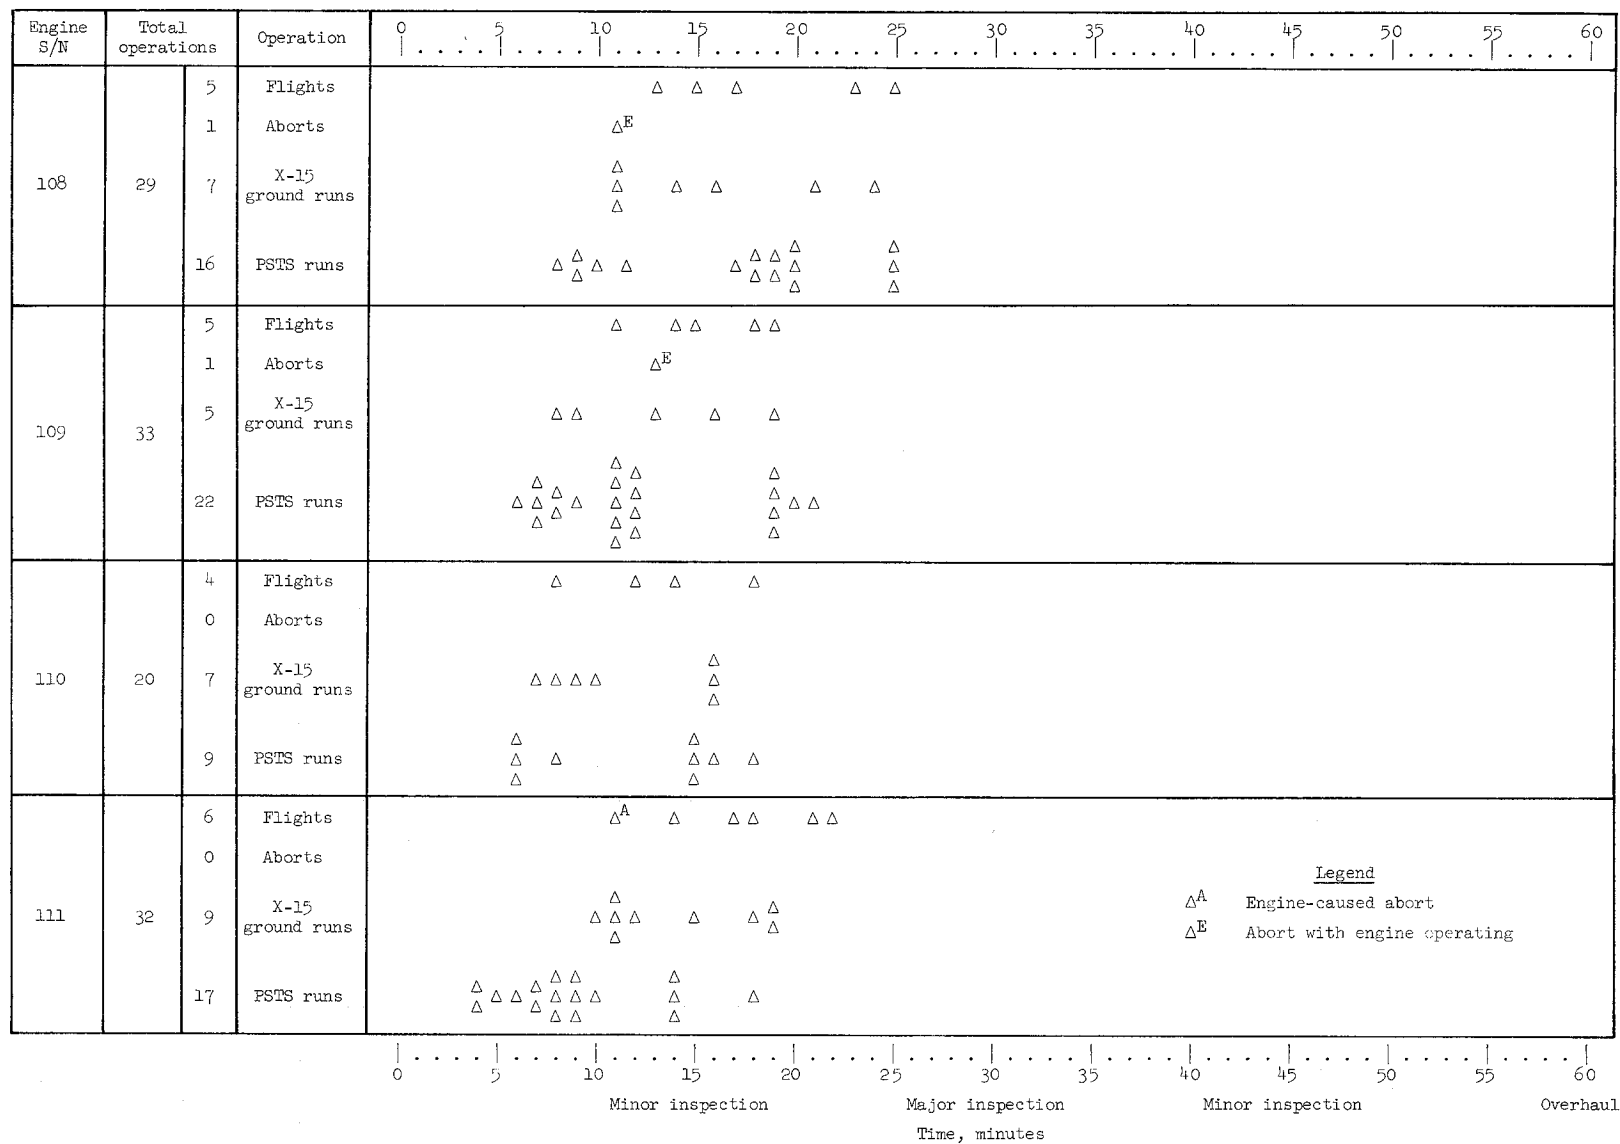
(a) Engine operations.

The service life of each flight engine and of the individual components is shown in figure 8(a) and figure 8(b), respectively. Theoretically, there is no difference in the operational reliability of the available engines, but engine operations per successful flight average from 3.6 to 47 for the various engines, with an overall average of 5 operations per flight. Removal of major components is significant in that a large amount of disassembly, checkout, and reassembly time is required to accomplish the chamber or turbopump changes, thus adding greatly to the effort required to maintain the engines. Information on engine S/N 105 is limited, since the engine was damaged beyond repair early in the program by an explosion in the X-15-3 airplane.

Figure 8.- YLR99 engine service life.

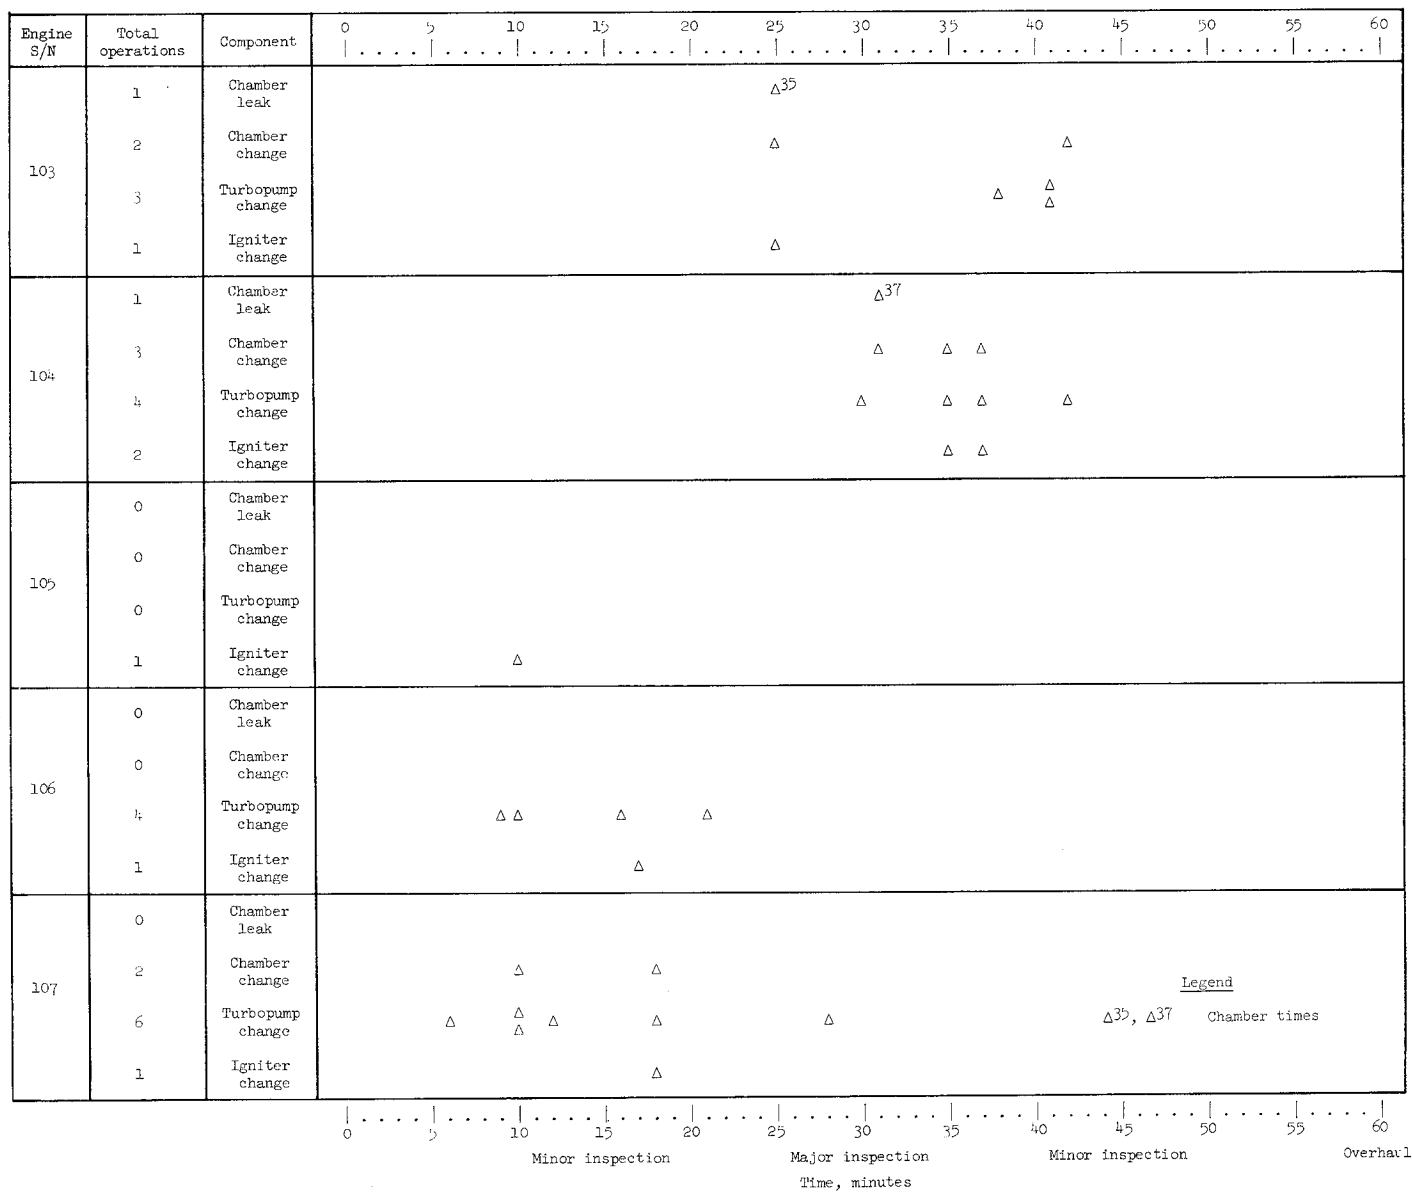
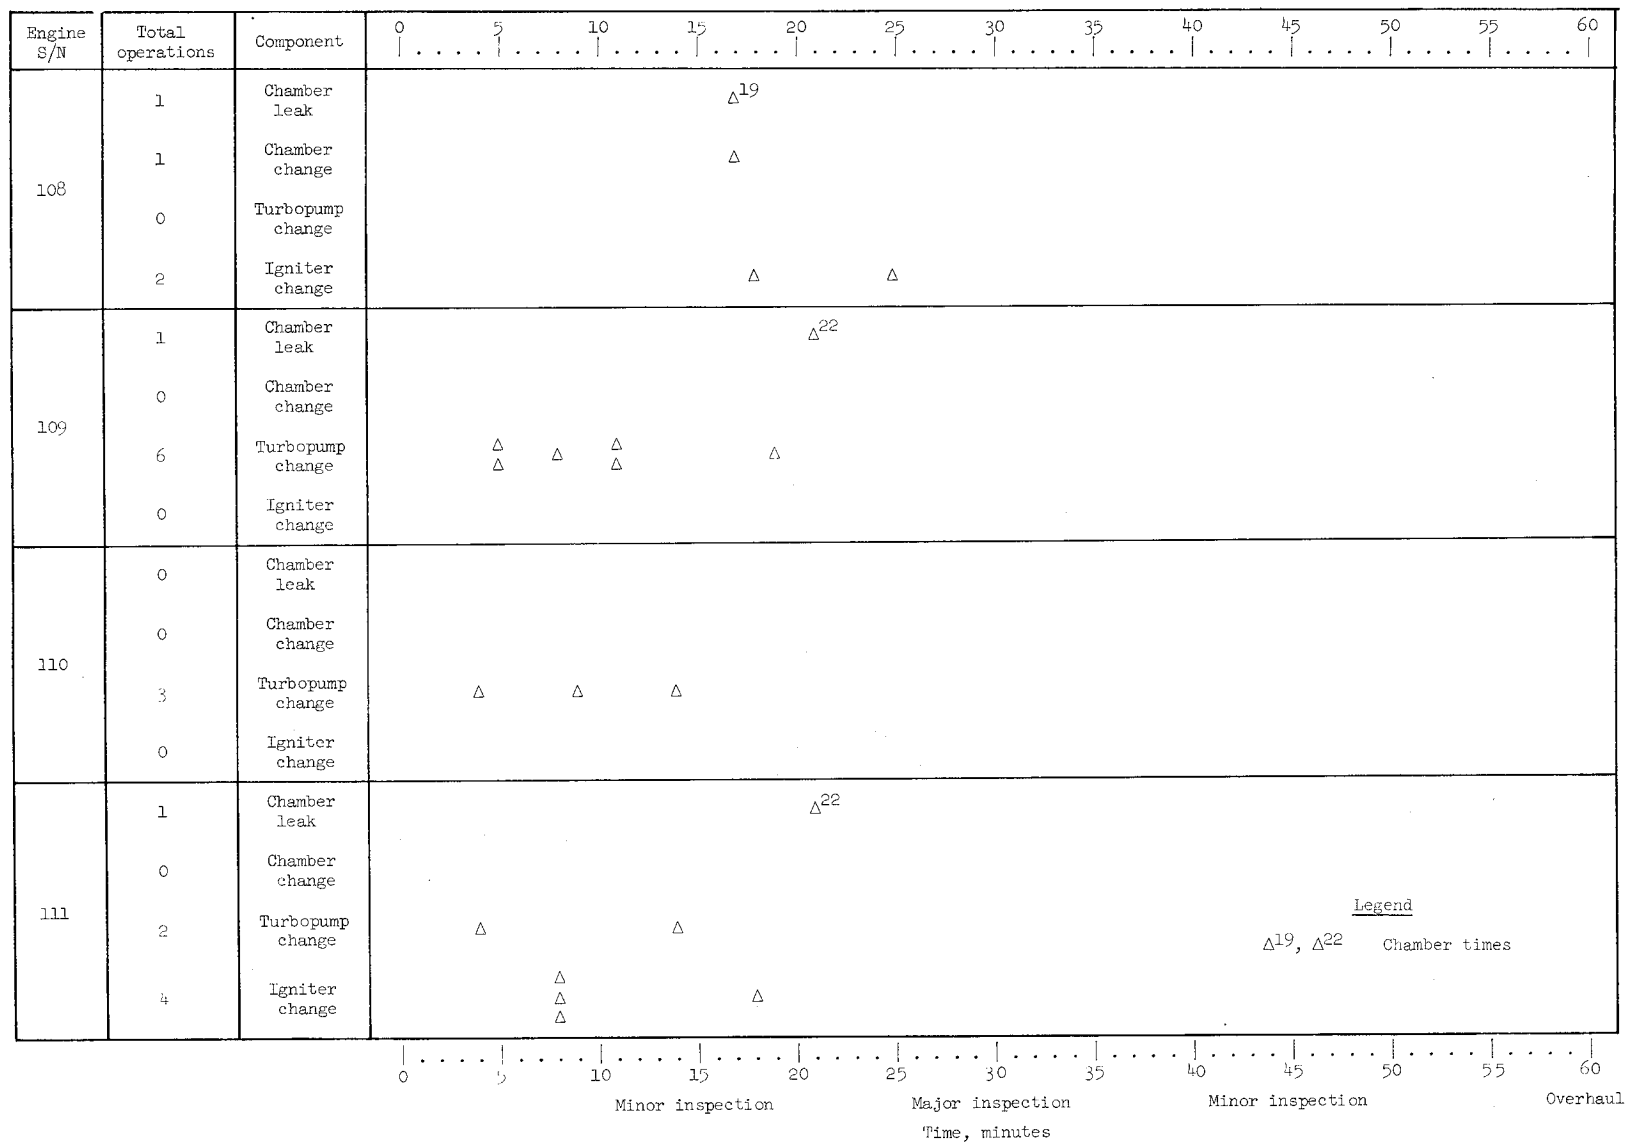
(b) Major component replacements.

Figure 8.- Continued.

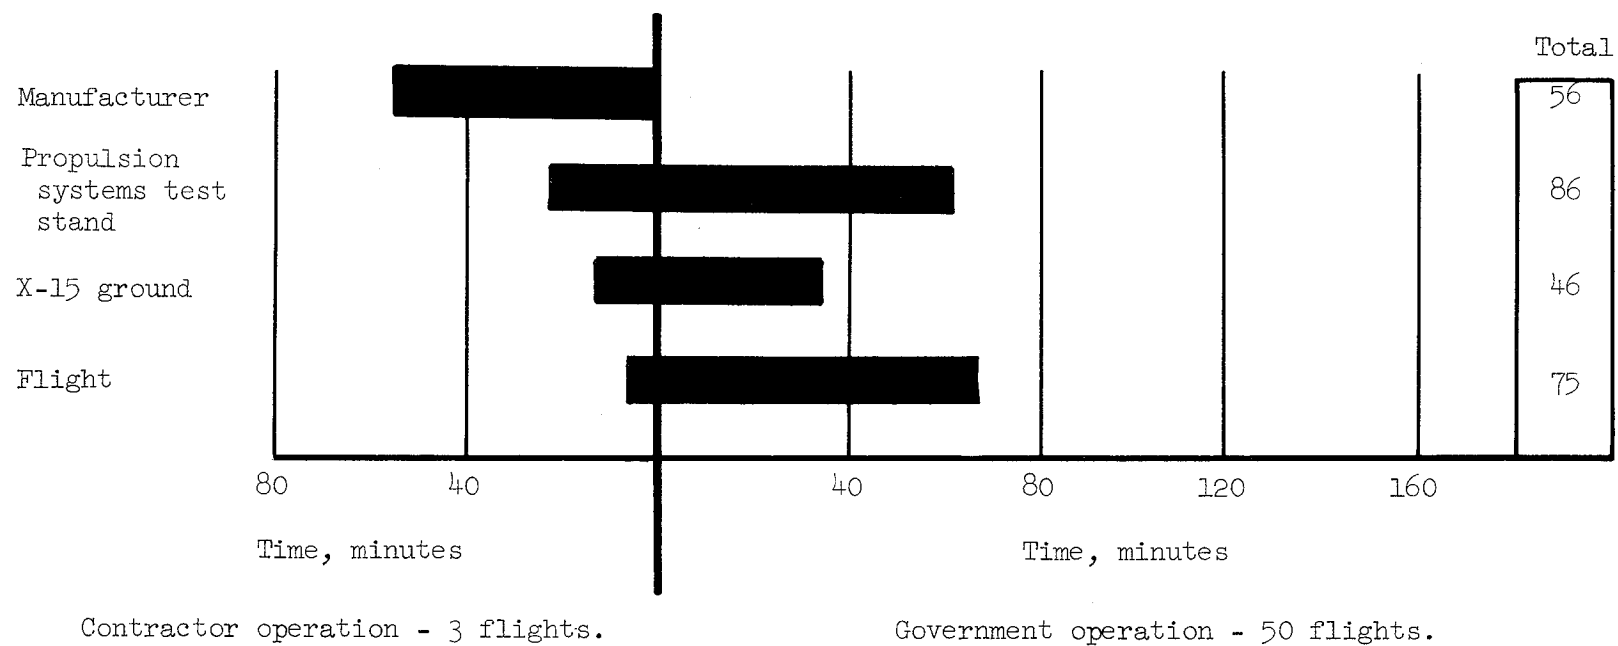
Engine operation time during the program is summarized in figure 9, which presents a graphical comparison of operating time accrued on flight engines. As shown, actual flight time accounts for less than one-third of the total time. Contractor time consists of development and demonstration firings.

Figure 9.- Summary of YLR99 flight engine time.

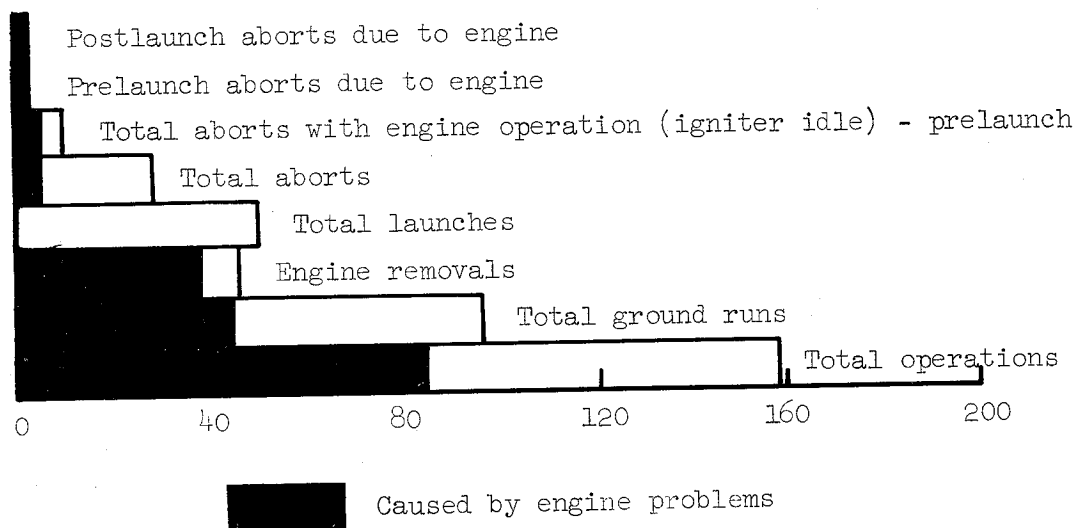
Figure 10 is a summary of the various types of operations in the engine program. Aborts refer to instances when the mission is cut short because of a malfunction. A prelaunch abort consists of returning to Edwards with the X-15 still attached to the B-52. A postlaunch abort requires an emergency landing at a dry lake near the launch area. The one postlaunch abort that has occurred was caused by a pressure-switch failure at launch. Engine removals are significant in that the flight schedule is often delayed because of the time involved in changing engines and the availability of operational engines. The average of nearly 1 engine removal per flight indicates that the possibility of replacement engines remaining operational for several flights is low.

Figure 10.- Summary of YLR99 flight-engine operation in Government program.
